Project YD 512-12
Technical Note TN-215
4 April 1955

SALT WATER CORROSION TEST OF ROLLING SURFACE BEARING
SWIVELS

U. S. Naval Civil Engineering Research and Evaluation Laboratory
Port Hueneme, California

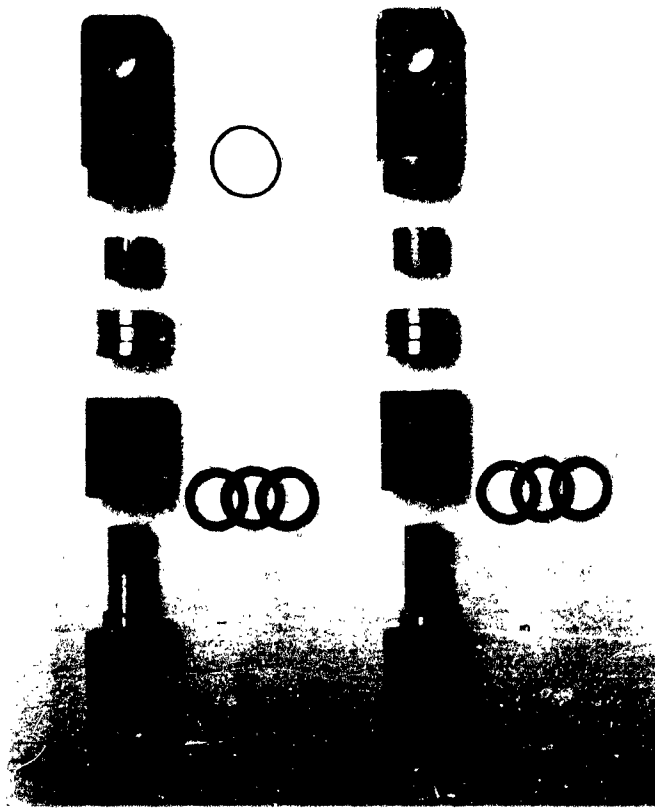
Figure 2. Laboratory tested Miller G-3 swivels disassembled.

- Item 1. Miller swivel immersed in 30 feet of water.
- Item 3. Miller swivel immersed in 5 feet of water.

The Miller swivel is a product of the General Machine and Welding Works Inc., Pomona, California. This make of swivel is equipped with three angular contact ball bearing sets which provide for free rotation of the swivel under load, and transmission of load thrust to the swivel barrel. The swivels tested by the Laboratory are manufacturer's Model G, Type 3 (eye and eye connections), rated by the manufacturer at 72,000 lbs "maximum load" and 24,000 lbs "working load". The G-3 swivel weighs approximately 41 lbs, is 4 inches in diameter, 14 1/2 inches in overall length, and is designed for use with 1 inch wire rope or equivalent. Swivels number 1 and 3 of Figure 1 are the Miller swivels after more than one year immersion in sea water. Figure 2 shows the same swivels disassembled.

It can be seen from Figures 2 and 4 that interior corrosion of all four swivels tested by the Laboratory was not severe, and although Laboratory tests were limited in duration, evidence obtained indicates that both makes of swivels will operate satisfactorily for a lengthy period of submergence. It is probable that the greater ease of water access to the bearings of the Flexo swivel would cause disabling bearing corrosion sooner than in the case of the Miller swivel. The condition of continuous submergence does not, however, appear to be the critical condition, as far as the effects of corrosion are concerned. In most uses, if not all, it is probable that the swivel will be raised occasionally either because of the nature of its use or for routine inspection. This exposure of the swivel alternately to sea water and to air will constitute the critical condition bearing on the life of the swivel as far as corrosion effects are concerned. The Flexo swivel would not be satisfactory under these conditions, in its present design, due primarily to the susceptibility of the male-female barrel joint to severe corrosion and secondarily to the comparative ease of water, and presumably, air penetration to the swivel interior. The design of the Miller swivel, on the other hand, is such that only corrosion of the bearings has an appreciable affect on swivel performance, and such corrosion is inhibited, to a much greater extent than in the case of the Flexo swivel, by moisture seals. Although the effectiveness of these seals apparently varies inversely as the depth of water to which they are subjected, they do constitute a definite point of superiority over the seal-less swivel. If a seal completely moisture proof at high pressure could be provided for the Miller swivel, there would be no question as to its suitability for service involving deep water immersion.

A comparison of Figures 2 and 4 makes obvious another advantage of the Miller swivel, i.e., its simplicity of design. This factor would seem to work in favor of the Miller swivel regardless of the service to which it was put.

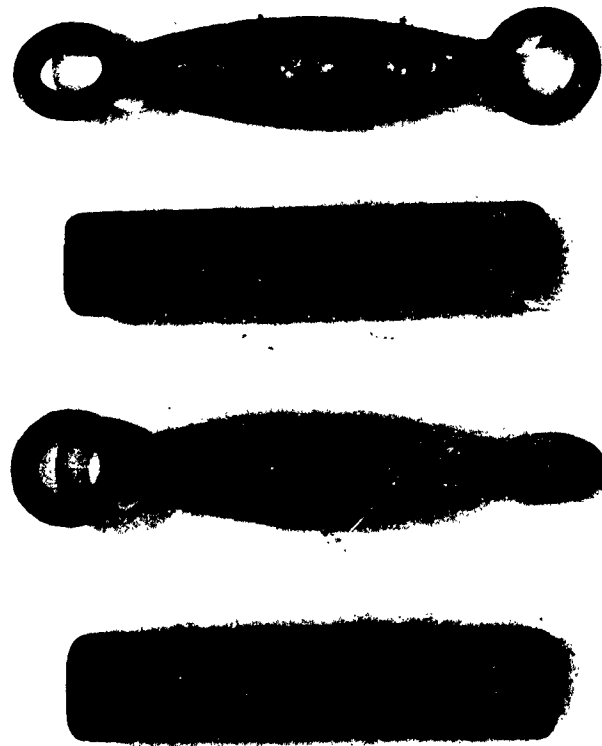
Figure 1. Laboratory tested swivels after removal from water.

- Item 1. Miller G-3 swivel immersed in 30 feet of water for nearly 14 months.
- Item 2. Flexo 400 swivel immersed in 30 feet of water for nearly 14 months.
- Item 3. Miller G-3 swivel immersed in 5 feet of water for 12 months.
- Item 4. Flexo 400 swivel immersed in 5 feet of water for 12 months.

One each of the Miller and Flexo swivels was used as a portion of the gear for mooring a 5 x 12 pontoon barge in approximately 30 feet of water. Two sets of ground tackle were used in the mooring; each consisted of 200 feet of wire rope connected at one end to the barge and at the other end to a spherical buoy. A short length of wire rope connected the buoy to one of the swivels and another length of wire rope joined the swivel and a 30,000 lb anchor lying on the bottom of the bay. Each set of tackle was so assembled that each of the two swivels were immersed in approximately 5 feet of water for a period of 12 months. Items 3 and 4 of Figure 1 are these two swivels.

Swivels 1 and 2 of Figure 1, the second of the two Miller and two Flexo swivels, were hung from the side of the barge and allowed to rest on the bottom of the bay in approximately 30 feet of water for nearly 14 months.

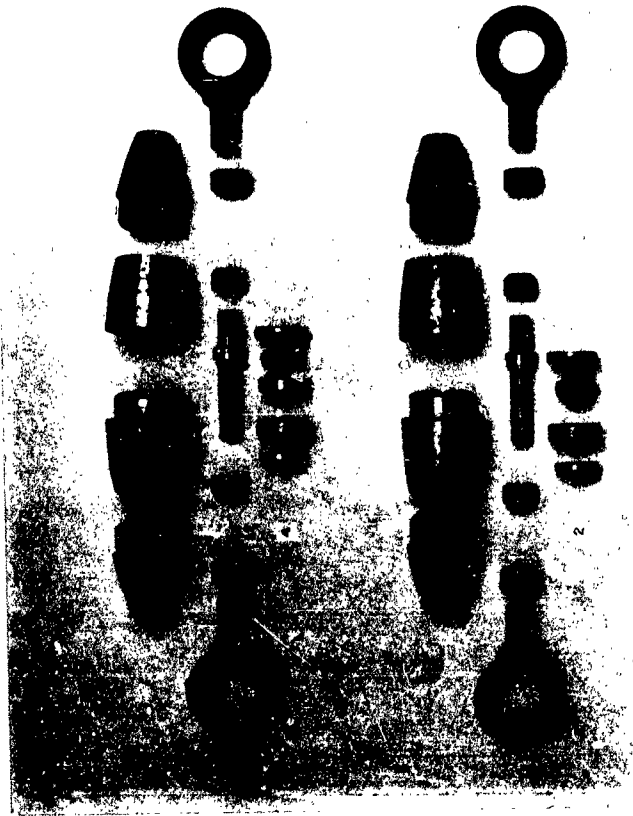
Figure 4. Disassembled Flexo 400 swivels tested by the Laboratory.
Item 2. Flexo swivel immersed in 30 feet of water.
Item 4. Flexo swivel immersed in 5 feet of water.

The Flexo swivel is manufactured by the Flexo Machine Company of Chicago, Illinois. This make of swivel is equipped with a roller thrust bearing and a tapered roller bearing for both thrust and radial loads. The swivels tested by the Laboratory are Flexo number 400. This swivel weighs about 40 lbs, is 4 inches in maximum diameter, 14 1/2 inches long, and is rated by the manufacturer at 46,000 lbs "maximum safe load". It is designed for use with 1 inch wire rope or equivalent. Swivels number 2 and 4 of Figure 1 are the Flexo swivels after one year immersion in sea water. Figure 4 shows the Flexo swivels disassembled.

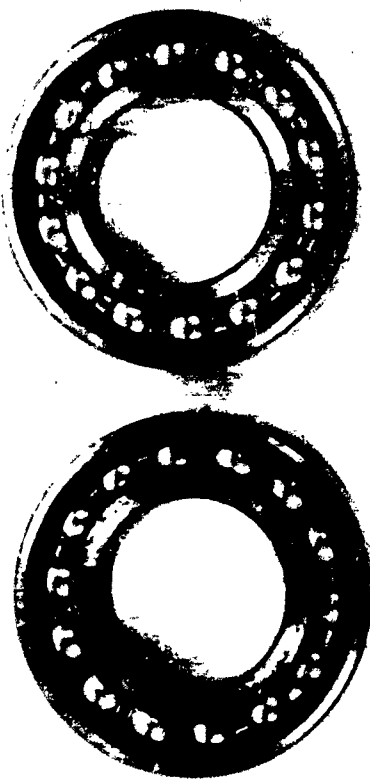
Figure 7. Ball bearings from Laboratory tested Miller G-3 swivels.
 Item 1. Bearing from swivel immersed in 30 feet of water.
 Item 3. Bearing from swivel immersed in 5 feet of water.

A small amount of moisture had penetrated to the bearings of Miller swivel No. 1 resulting in some corrosion although the bearings rolled freely. There was no interior corrosion of the Miller swivel No. 3 and no other evidence of moisture was found. One set of ball bearings from each of the two Miller swivels is shown in Figure 7 for comparison.

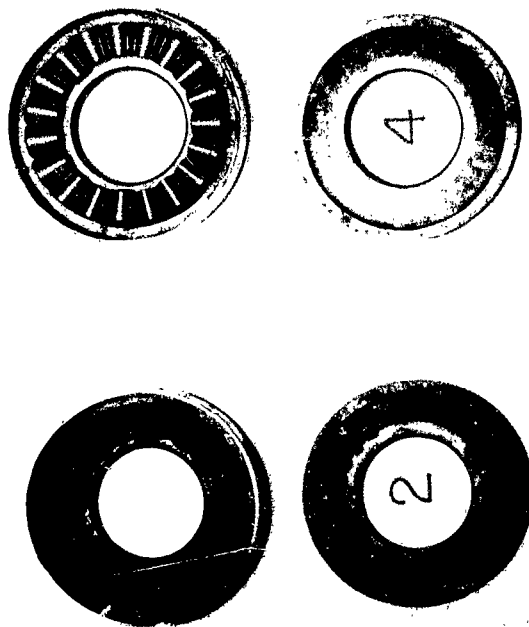
Figure 8. Thrust bearings from Laboratory tested Flexo 400 swivel.
 Item 2. Bearing from swivel immersed in 30 feet of water.
 Item 4. Bearing from swivel immersed in 5 feet of water.

On disassembly, water was found in both Flexo swivels. Water had penetrated the grease with which the bearings were packed and had caused some corrosion of the bearings. Corrosion was slight in the case of swivel No. 4 (5 foot submergence) and greater in swivel No. 2 (30 foot submergence). Figure 8 shows the difference in corrosion of the thrust bearings of the two swivels. Figure 9 is the tapered roller bearing from swivel No. 2. Corrosion of this bearing was more extensive than that of swivel No. 4, although both bearings rolled freely.

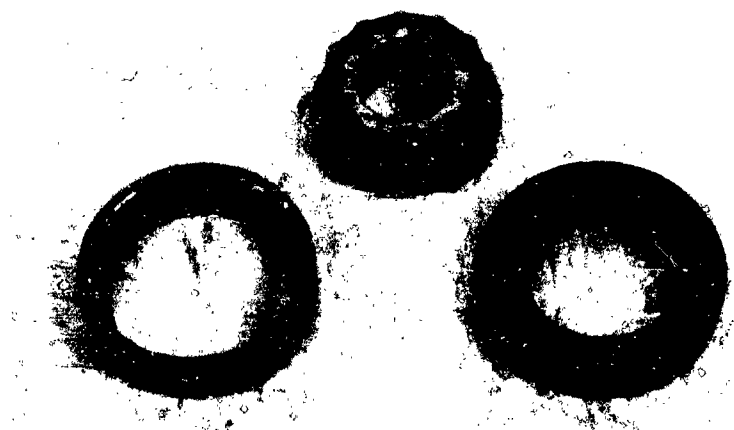
Figure 9. Tapered roller bearing, bearing cup and grease seal from Laboratory tested Flexo 400 swivel immersed in 30 feet of water.
